# CASE STUDY 02 MACHINE EXTRACTION HARD ROCK MINE

FOSTERVILLE GOLD MINE 2021

# SUCCESSFUL HARD ROCK MINE EXTRACTIONS

### **MED Extraction Case Study**

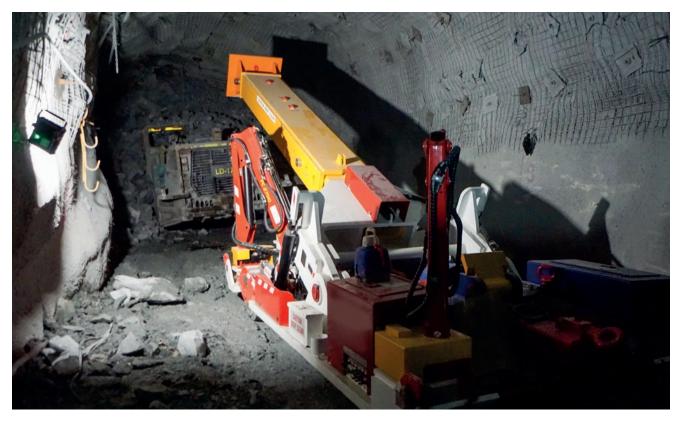
**1.** MED360 is being moved into place following the preparation of a solid and level base before the extraction commences.

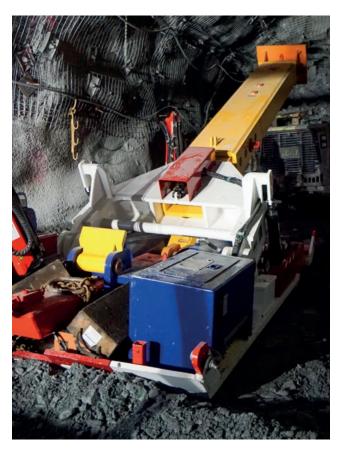
**2.** The MED360 is positioned over the prepared base.

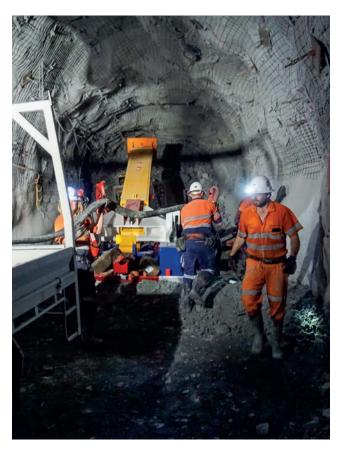
**3.** The tow slings and other equipment are moved into position.

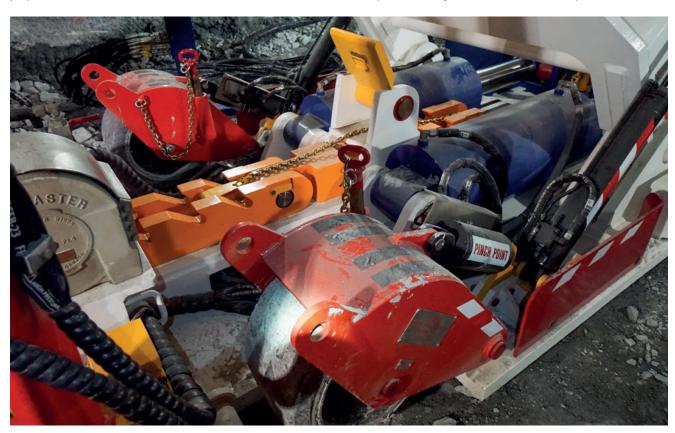
**6.** Image of the racks being assembled and pulled through the MED into position using the winch.

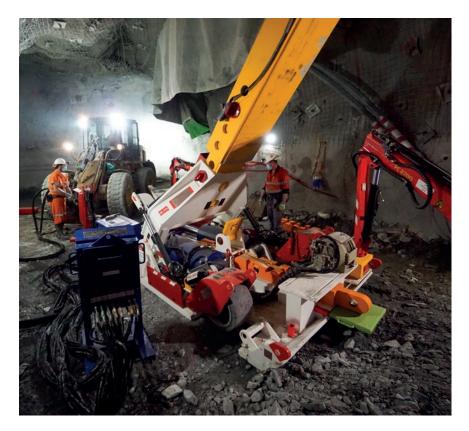
**7.** The control station and hydraulic hoses are moved into position and connected. In this case the auxiliary implement controls on an IT loader are used to operate the MED.

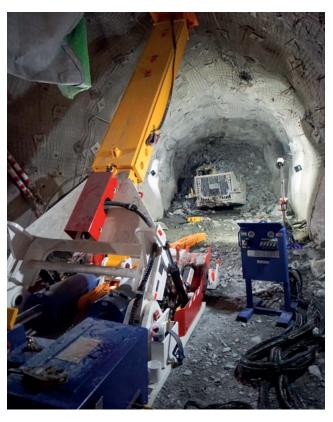
**12.** View of the buried asset from the rear of the MED360.

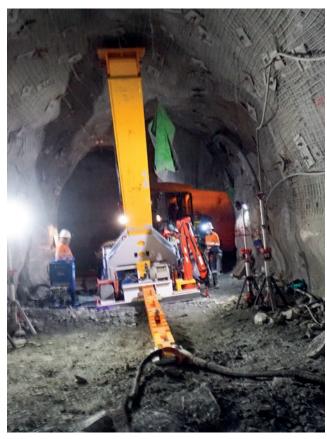
**14.** The MED360 is ready to commence the bedding in process and subsequent extraction.

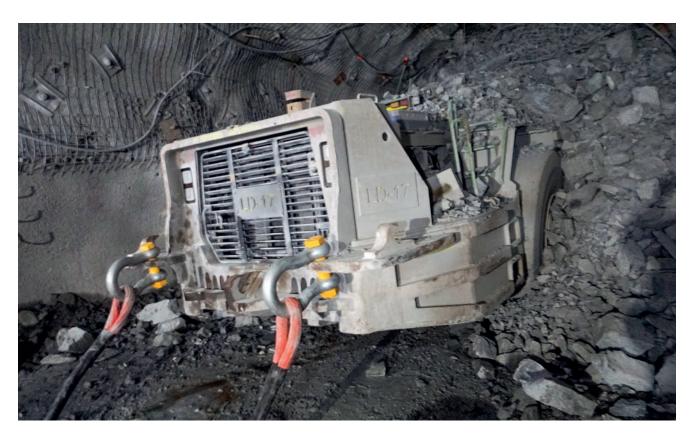
**15.** The tow slings are attached to the 'D-shackles' and readied for the machine extraction.

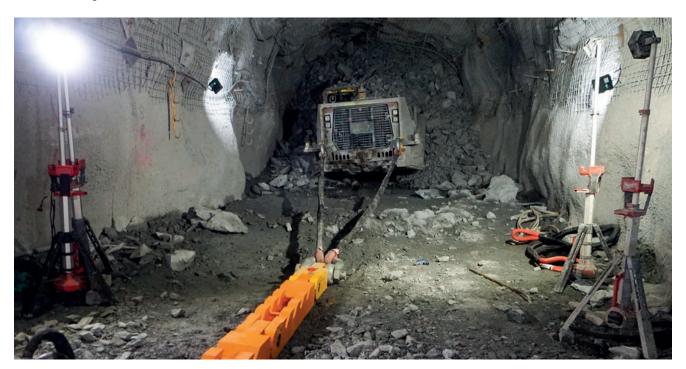
**16.** Tension is applied to the tow slings and the extraction process commences.
